# Manhole Inspection Summary

Manhole # S33A\_\_026MH

Insp Date: **8/18/09 11:09 AM**

**Location** Address: **515 CENTRE ST** Cross Street: **CATHEDRAL ST**

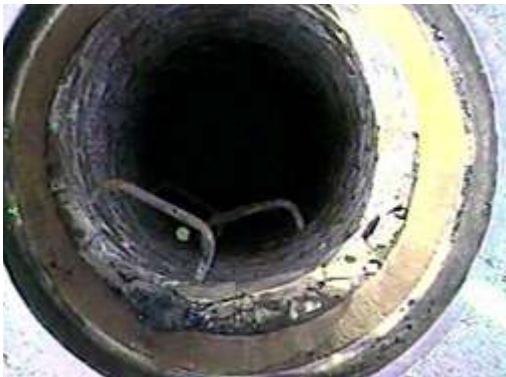
Defect 3

DEBRIS ON BENCH

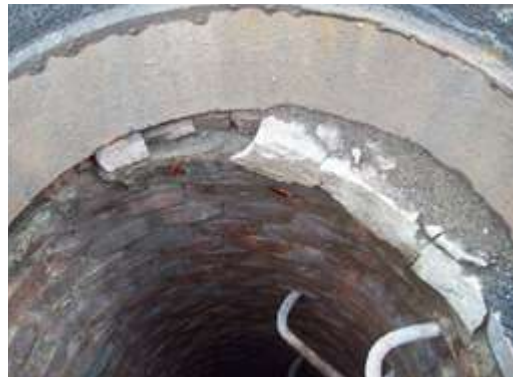
Defect 2

**Frame** Offset: **3** (in.) Condition: ☒ Sound ☐ Cracked ☐ Leaks

FRAME OFFSET

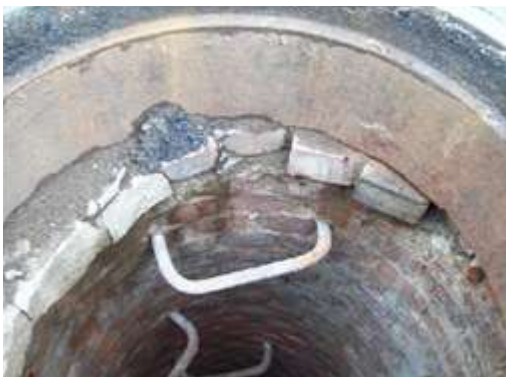
Defect 1

Condition: ☐ Sound ☒ **Cracked** ☐ Root Intrusion ☐ Loose Brick ☒ **Deteriorated**

Condition: ☐ Sound ☒ **Cracked** ☐ Root Intrusion ☐ Loose Brick ☐ Deteriorated

cracked chimney and corbel

deteriorated frame adjustment
